BOATING ACCIDENT INVESTIGATIONS 1974, FIRE AND  
EXPLOSION

Underwriters' Laboratories,  
Incorporated

Report No. CG-D-119-75

**DEPARTMENT OF TRANSPORTATION  
UNITED STATES COAST GUARD**

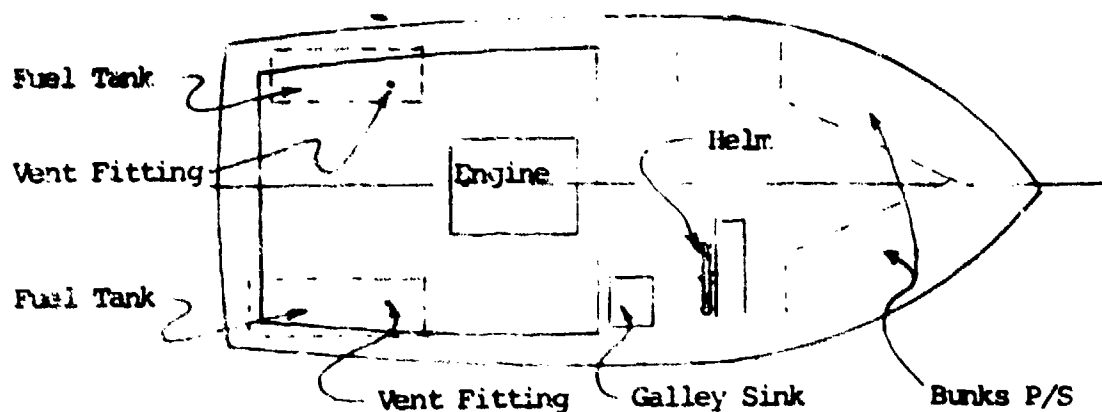
Figure No. 1

All of the facts and findings in this case tend to confirm that the source of fuel for the fire was from the missing vent plug from the port 42 gallon tank. The boat was filled until the sound indicated the fuel had reached the fill pipe. Although the exact amount is not known, the horizontal section of the fuel fill would fill up quickly and the major sound level change would occur when the fuel reached the vertical pipe. At that point the fuel would be pouring out of the missing vent opening to the bilge. The boat did not move for about 20 minutes which would allow additional fuel to be discharged due to the gradual increase in the temperature of the fuel. The fuel was delivered from an underground tank and the temperature of the engine compartment was probably about 50° C (122F) since the fresh water cooled engine would operate at about 82° C (180F).

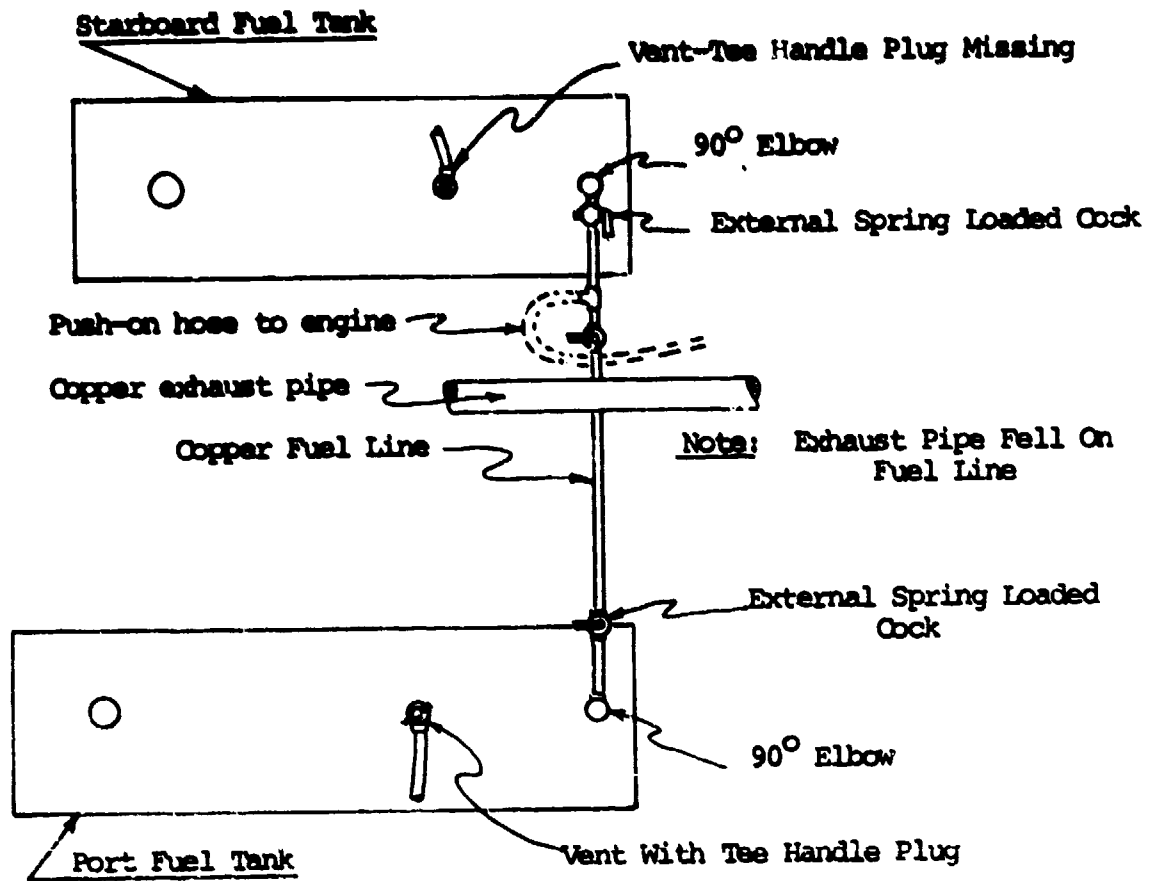
Diagram No. 1

Fuel Feed System Layout

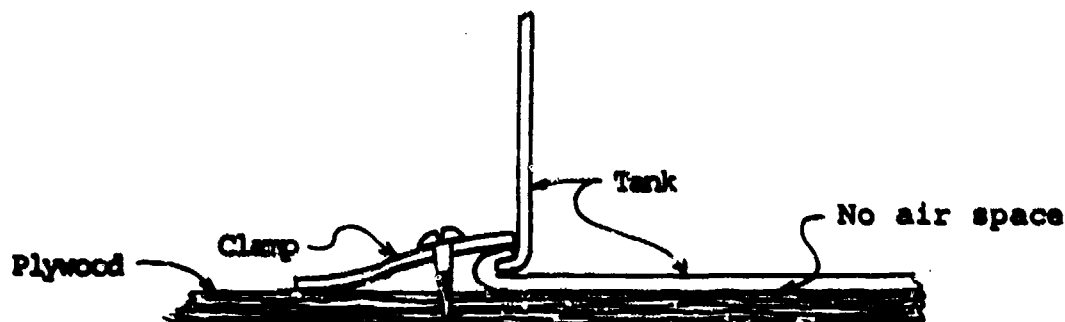
Figure No. 1

The single 18 gallonterneplate fuel tank was located outboard of the engine on the port side below the aft deck. See Photograph No. 3. The tank was set on a flat surface and secured by a metal strip that clamped the tank flange. See Figure No. 1.

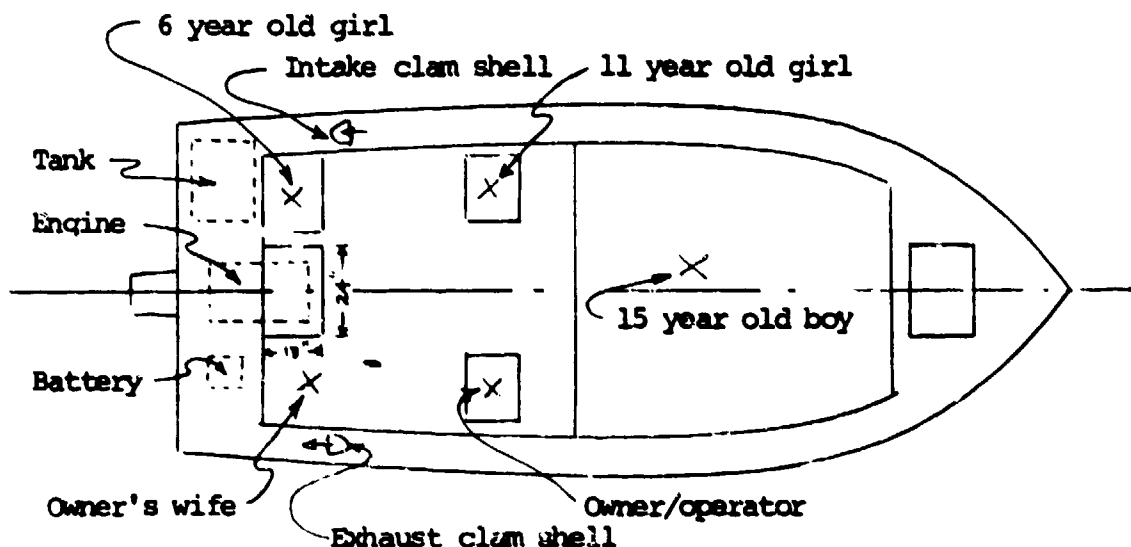
Diagram No. 1

The boat has a 4 cylinder in-line Mercruiser inboard engine with an inboard/outdrive propulsion unit. The engine was located aft at the transom. The aft deck is hinged at the transom and the engine box is hinged at the forward edge. The hinged deck aft is 24 inches deep and the engine box extends into the cockpit approximately 13 inches. The latter is 24 inches wide. See Diagram No. 1.

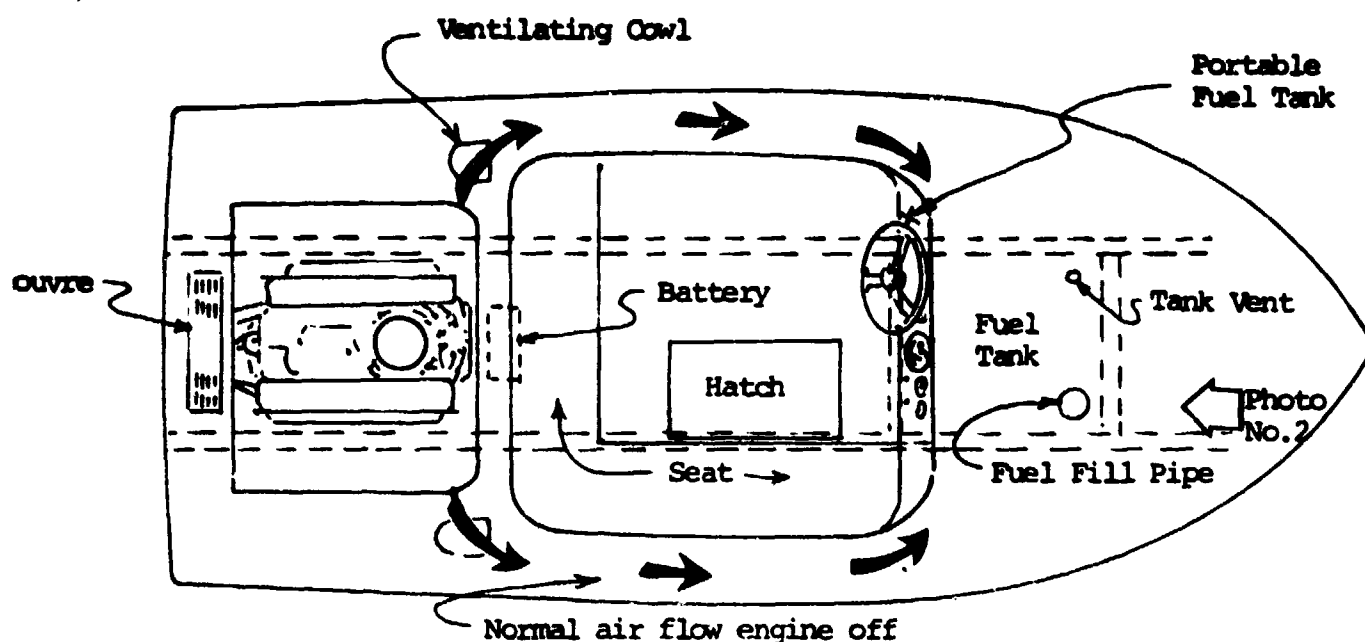
FIGURE 1

The boat had a conventional speedboat layout, with a midship cockpit, bow deck and engine compartment aft. See Photograph No. 1. The 1/0 engine was below the aft deck with a large flush engine hatch. The hatch was hinged at the aft end and latched at the forward edge. The engine space was inter-connected to the fuel tank space by openings between the cockpit ceiling and hull. Limber holes in the engine space bulkhead and the floors would permit the free flow of bilge water between the engine and fuel tank space. See Figure No. 1.

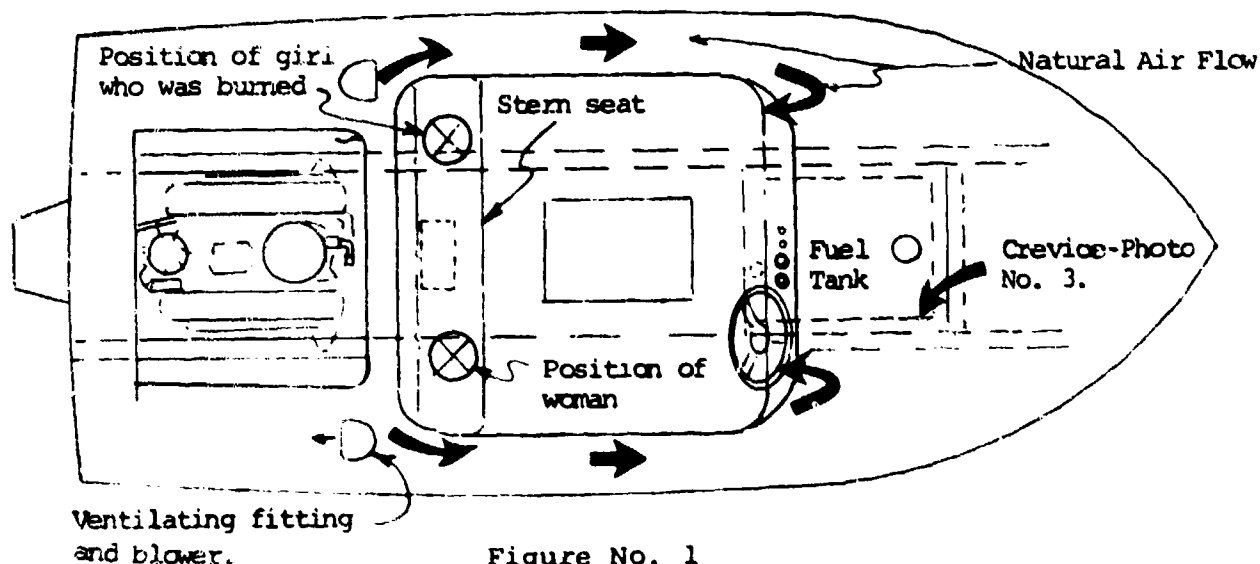
Figure No. 1

The boat has a single 25 gallon hot-dipped galvanized fuel tank, foamed in place in the bow. The tank is positioned between the two fore and aft stringers below the foot rest under the dash board. The fuel tank shut-off valve is accessible through an access plate directly below the dash. See Photograph No. 2.

The boat's natural ventilating system consists of two clam shells forward and outboard of the engine. The cowls are fitted with wire reinforced plastic ducting to the bilge. The starboard clam shell is trimmed as an exhaust and the port clam shell as an intake. A power blower is located under the starboard clam shell. Although the boat has deck cowls, the major ventilating air flow would be through the tunnel spaces along the sides of the cockpit due to the differential pressure created under the dash.

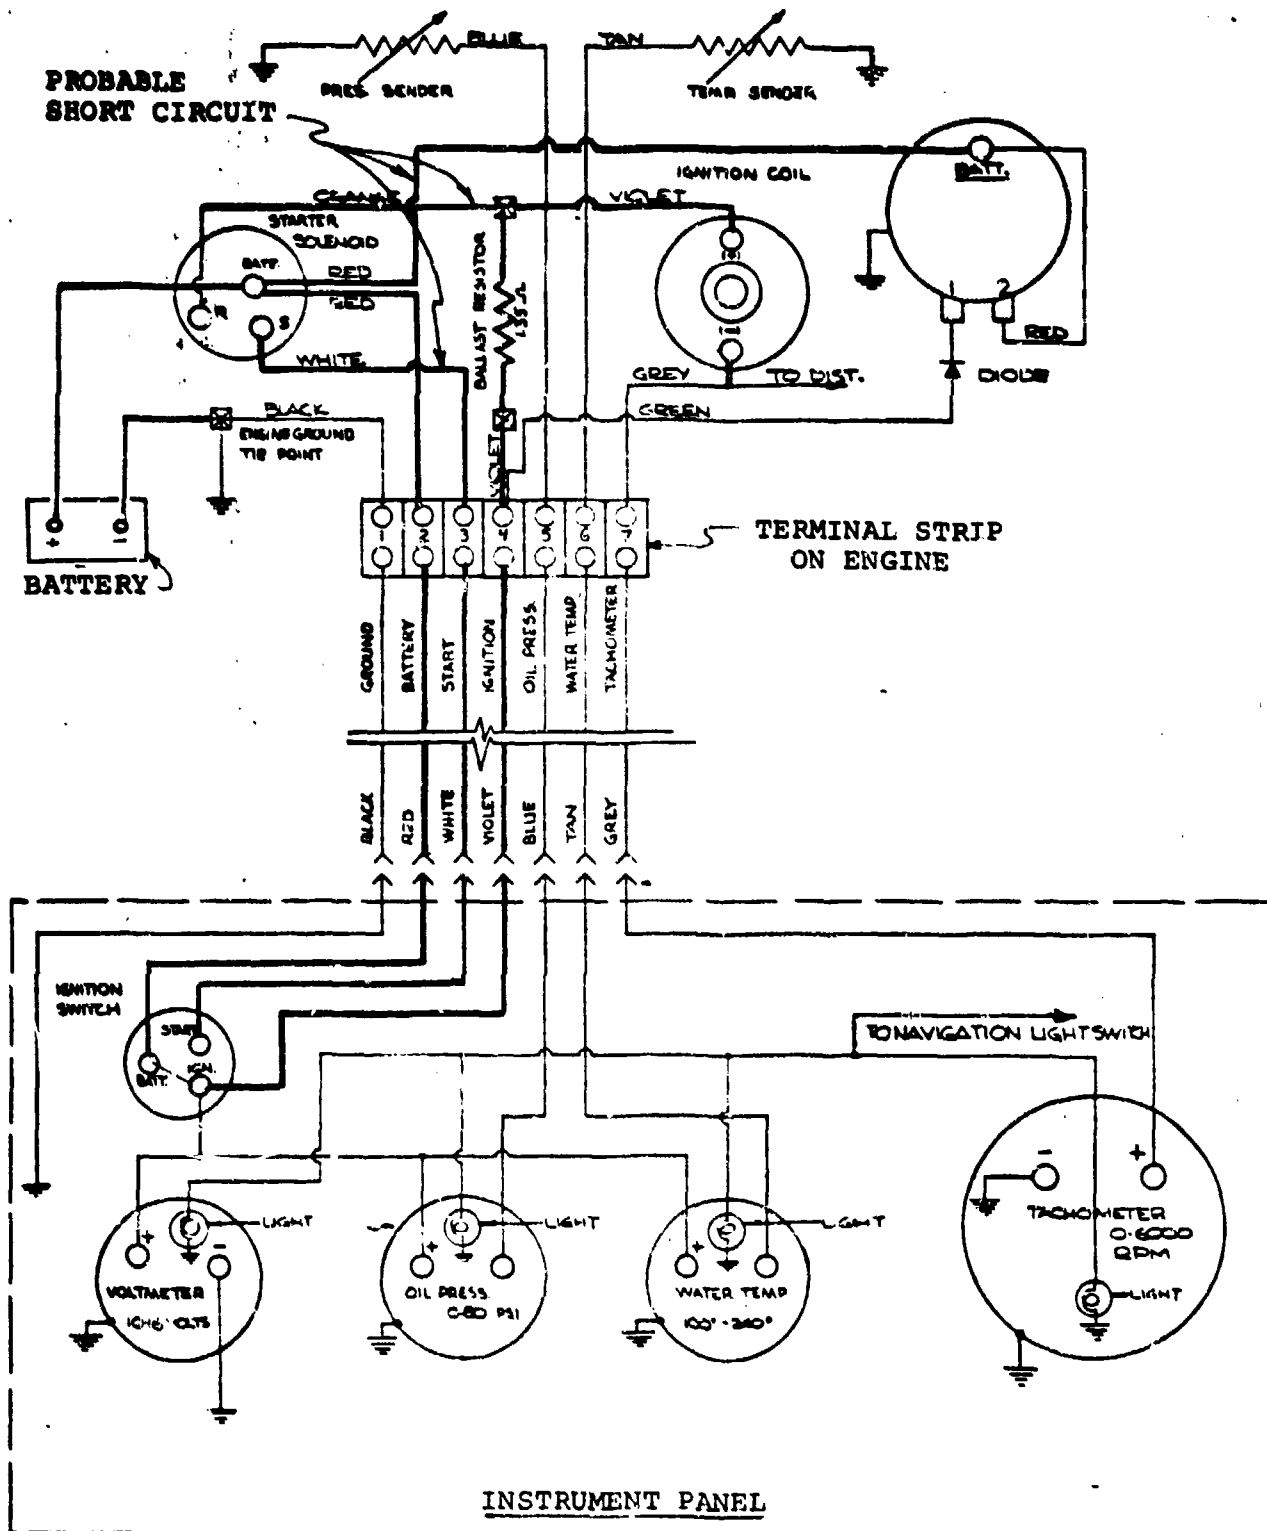
FIGURE 2

- (a) Master Battery Switch - The boat was not equipped with a master battery switch. Since the boat operator shut off the fuel valve almost immediately, it is quite probable that he would also have shut off a master switch if one had been provided. The master switch might have prevented the electrical fire behind the instrument panel.
- (b) Overcurrent Protection - The engine wiring was such that there were several unprotected wires. The power lead from the starter solenoid to the ignition switch and panel was unprotected. A short circuit in the ignition, alternator or the starter solenoid circuit could result in a dead short that could ignite the electrical harness from the engine compartment to the instrument panel. See Figure No. 2.
